# Sewer Renovation by Open Cut Excavation

Project included burial depths up to 50 ft deep.

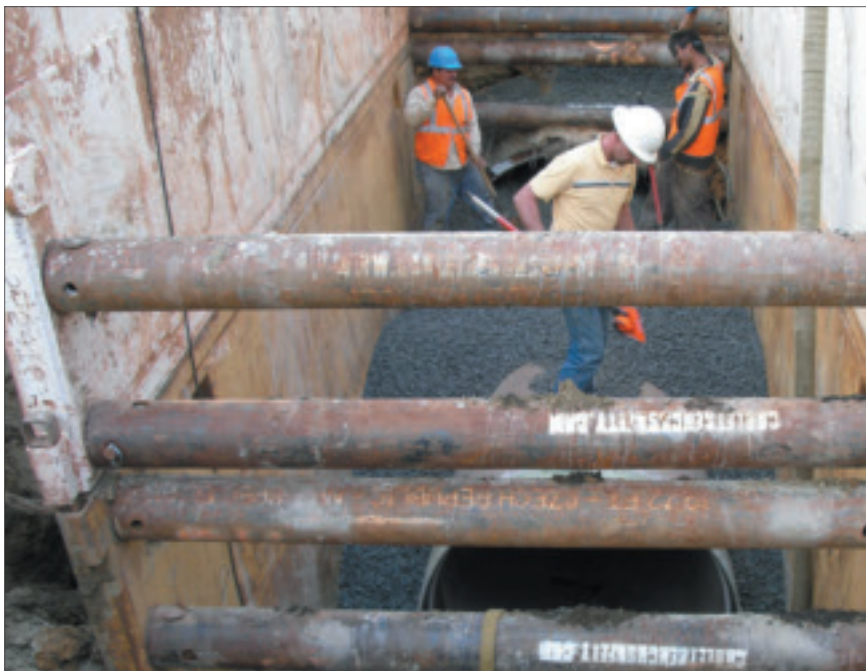
*The crushed granite used for backfill covered up to 70 percent of the OD on the shallower depths. For the deeper covers of more than 15 ft, crews placed the same material 12 in. over the top of the pipe.*

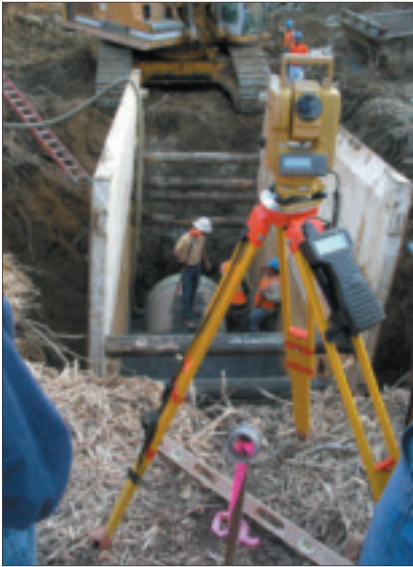
*A surveyor's total station is used to direct the location of pipe in the trench during the construction of Deep River Outfall Segment 2 in High Point, NC.*
